1 **Coupled Effects of Simultaneous Autogenous Self-Healing and** 2 **Sustained Flexural Loading in Cementitious Materials**

3 Benoît Hilloulin*, Carol Youssef Namnoum, Frédéric Grondin, Ahmed Loukili
4 Nantes Université, Ecole Centrale Nantes, CNRS, GeM, UMR 6183, F-44000 Nantes,
5 France

8 **Abstract**

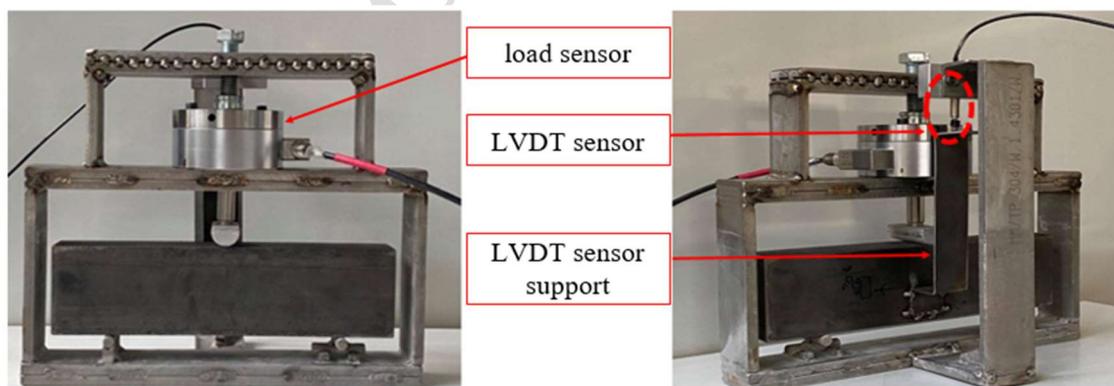
156 **Figure 1.** Three-point flexural loading test setup for measuring creep underwater.

133 In order to study the effect of self-healing under sustained mechanical loading, a specific
134 three-point sustained flexural loading device was developed. Several reasons supported
135 the development of this new loading device, such as portability and the need to quickly
136 adjust the bending load applied to the low-strength specimens at an early age. In addition,
137 the main advantage of this device lies in the ability to perform early creep tests on pre-
138 cracked beams completely immersed in water to ensure the continuity of hydration of the
139 cement particles. The device was made of stainless steel because it was intended to be

140 used in water and not to generate corrosion products that could affect healing. The
141 thickness of the metal frame was adjusted to limit its deformations while ensuring its
142 portability and both the stability and the limited deformations of the frame were verified
143 using replacement specimens prior to testing.
144 Figure 2 shows the setup for sustained mechanical loading of a prismatic specimen. The
145 specimens were loaded using threaded rods. A load sensor was incorporated into the top
146 part of the frame to evaluate the load applied on the specimens and adjust it in real-time
147 using a dedicated screw. The load was applied at mid-span with a cylindrical tip to ensure
148 a linear load application. Deflection was measured at the center of the beam using an
149 LVDT sensor with a measuring range of ± 0.5 mm and an accuracy of $0.1 \mu\text{m}$, typically
150 used for short-term creep testing [34]. An aluminum stand glued to the center of the beam

151 supported the LVDT sensor and ensured that the sensor was out of the water, as the
152 sensors were not waterproof for long periods of time. Load values were recorded with an
153 accuracy of 5 N.

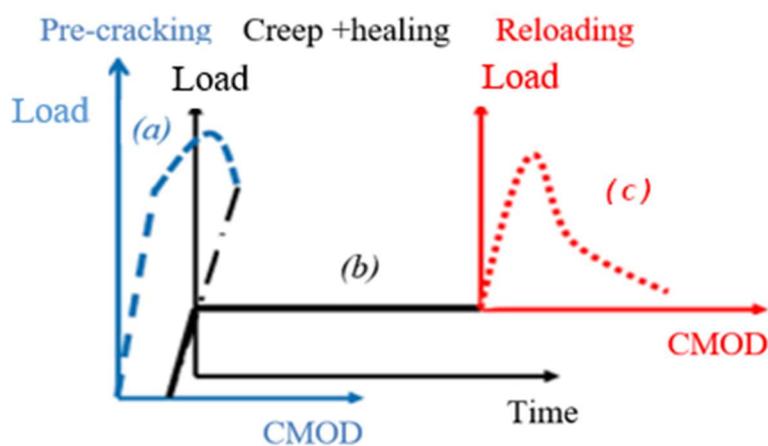
166 **Figure 2.** Loading principle during the creep-healing test.

158 The specimens were loaded using the following procedure (Fig. 3):

- 160 b) Healing: immersion in water with a constant sustained load for 26 days (40% of
 161 the residual load to avoid nonlinear creep [35]). Reference specimens were
 162 immersed without being loaded.
- 163 c) Reloading: CMOD-controlled three-point bending test to evaluate the mechanical
 164 recovery due to healing by comparing healed and reference specimens (see section
 165 2.2.3).

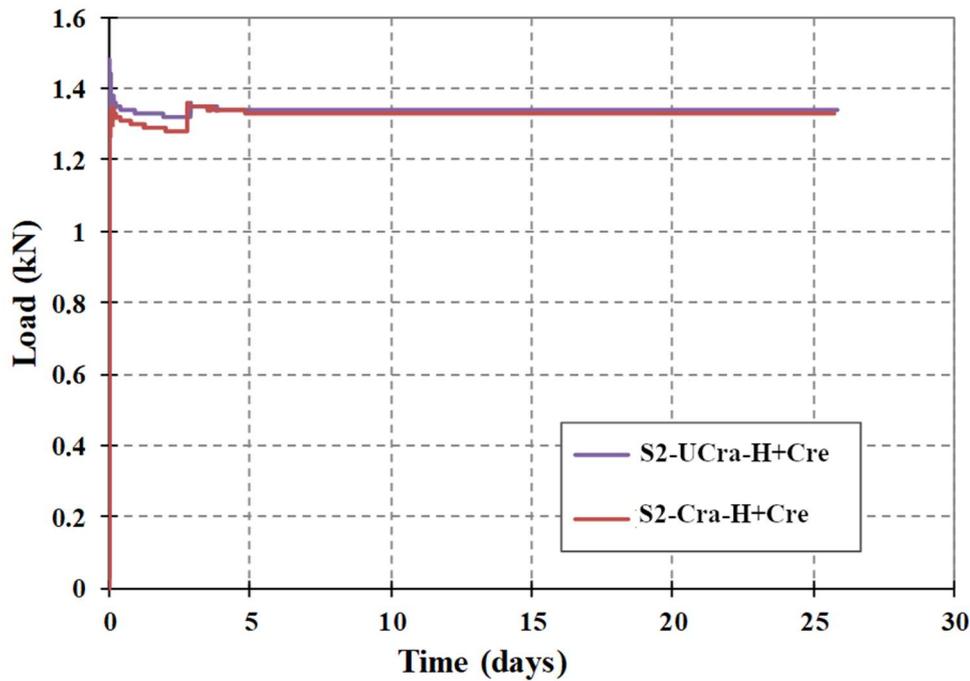
192 **Figure 3.** Load applied to the mortar specimens tested during the coupled test creep-
 193 self-healing.
 194
 195

181 For the uncracked beams, the value of the constant load for the creep test was the same
182 as for the healed beam prepared during the same casting. Fig. 4 shows the evolution of
183 the applied load for the two types of beams (S2-UCra-H+Cre and S2-Cra-H+Cre the
184 uncracked beam, and the cracked beam, resp., subjected to creep during immersion). As
185 shown in the figure, only a relatively limited relaxation occurred during the first five days.
186 The applied load was manually increased for about three days to limit the relaxation. The
187 complete program is shown in Fig. 5.

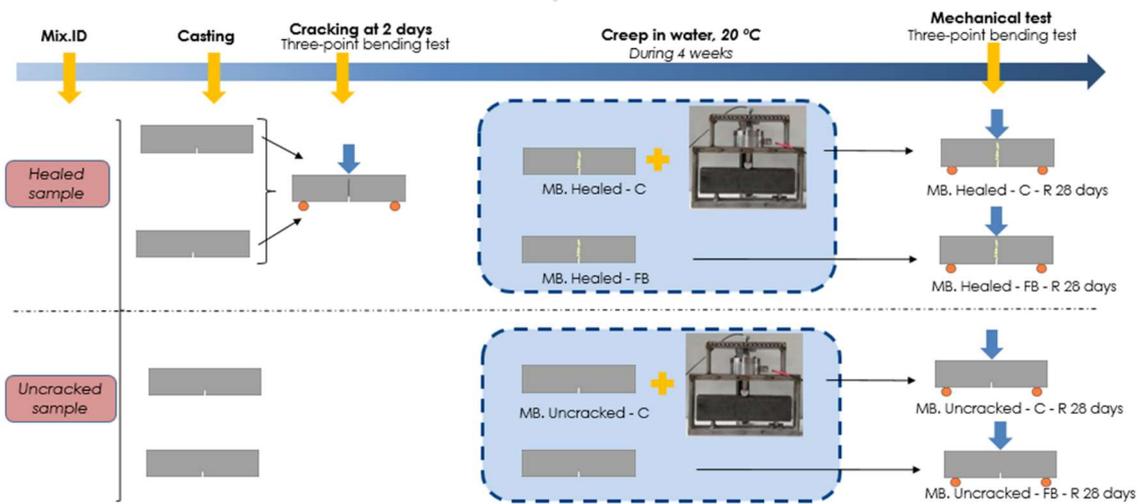
196 **Figure 4.** Creep – healing test program of mortar beams (MB refers to the mortar beam,
 197 C the creep loading and FB free bending).
 198

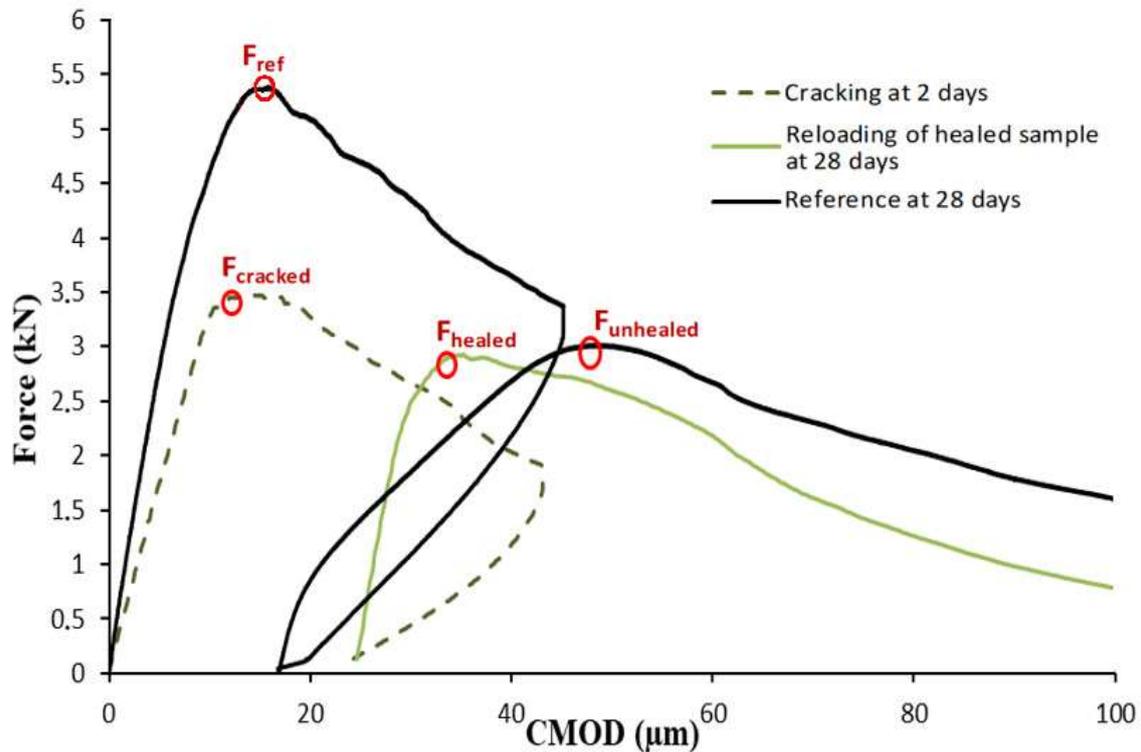
219 **Figure 5.** Example of load vs. CMOD curves for specimens submitted to creep healing
 220 and reference specimens; representation of quantities for calculation of mechanical
 221 indexes.

212 Where $F_{cracked}$ represents the maximum strength of the specimen during cracking at 2
213 days, F_{healed} the maximum strength of the healed specimens during reloading, F_{ref} the
214 maximum strength of the reference specimen loaded at 28 days, $F_{unhealed}$ the maximum
215 strength of the reference specimen during reloading, as represented in Fig. 6. Mean values
216 and standard deviations of the ratios were calculated and reported to evaluate the effect
217 of creep during self-healing on the final mechanical recovery.

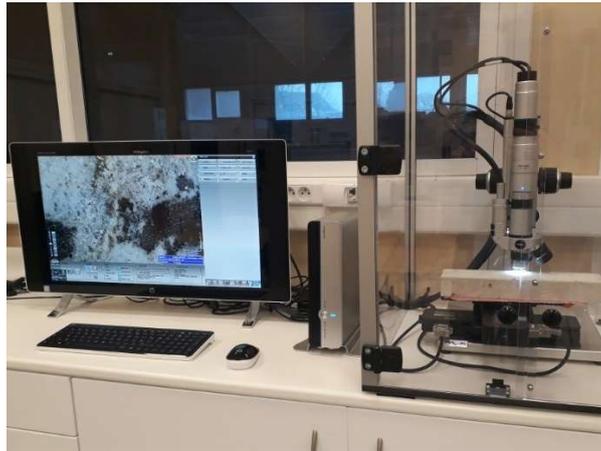
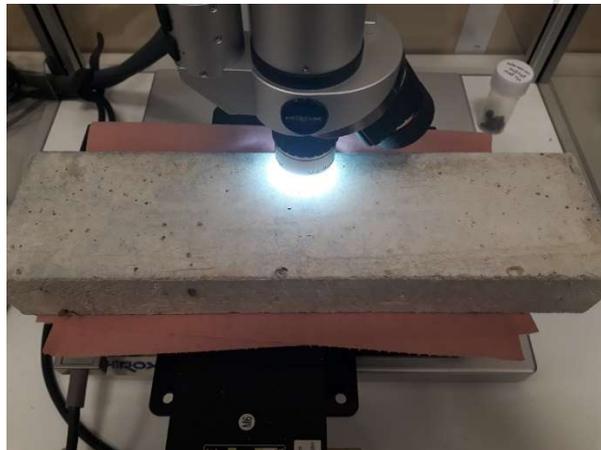
234 **Figure 6.** Photograph of the specimen observation under the optical microscope: a)
235 global view, b) close-up view of a specimen placed horizontally on top of a paper sheet.

224 Microscopic images of the cracks were taken using a Hirox RH 3000 3D optical
 225 microscope at $\times 50$ to $\times 400$ magnification. Under the microscope, several tracking marks
 226 were manually drawn on the specimens after cracking using a fine blue pen, and the
 227 corresponding images were saved as references. After the healing period, images of the
 228 same locations were taken to monitor the evolution of the crack width just before the
 229 beam was reloaded, as described in 2.2.3. Special care was taken in handling the
 230 specimens to avoid accidental breakage after creep. In addition, a thin sheet of paper was
 231 placed between the specimen and the metal motorized stage to prevent scratching of
 232 healing components, as illustrated in Fig. 6.

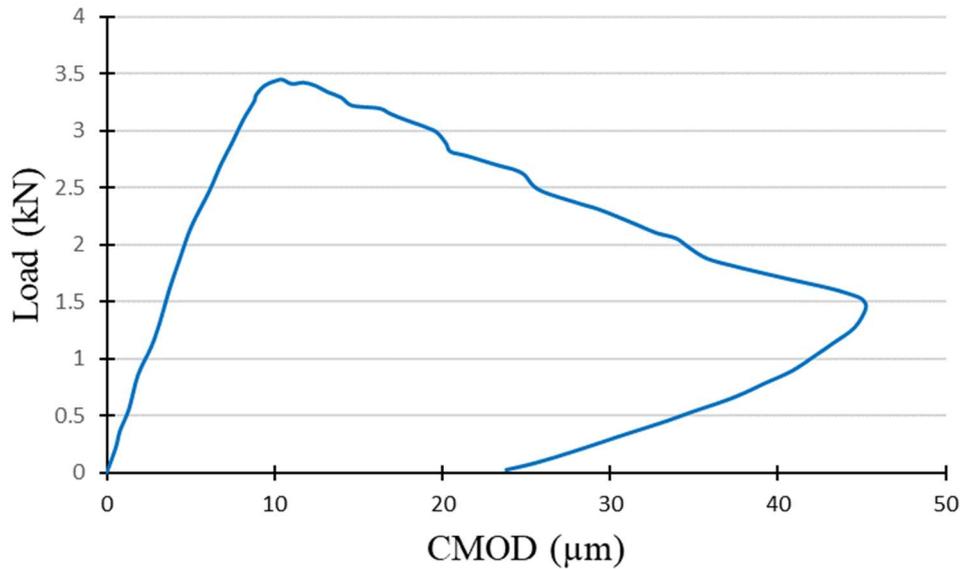
264
265 **Figure 7.** Evolution of typical load vs. CMOD curves during cracking by three-point
266 bending, at 2 days.

253 Fig. 7 shows typical load curves as a function of the CMOD measured during the pre-
 254 cracking phase at 2 days. The maximum strength of the specimen was 3.4 kN. The peak
 255 load occurred at CMOD values of 25 μm . After the peak load, the crack width increased
 256 and the load was removed when the CMOD reached 45 μm in order to obtain an actual
 257 crack width close to 10 μm as observed with a microscope (corresponding to a mean final
 258 CMOD after unloading of 23.8 μm). The variability of the ultimate strength and final
 259 crack characteristics was evaluated by analyzing the load curves and microscopic image
 260 analysis, as shown in Table 5. Such a limited final crack width has been previously
 261 reported to influence healing positively [25,38], and the reduced crack width variability
 262 ensures the best possible repeatability during the healing phase.

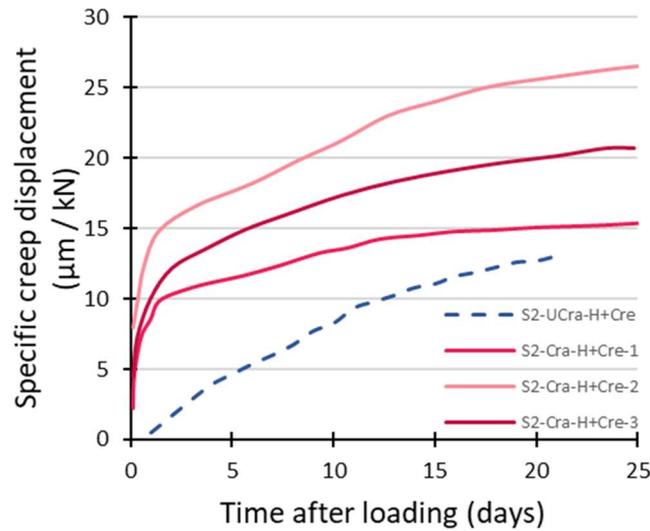
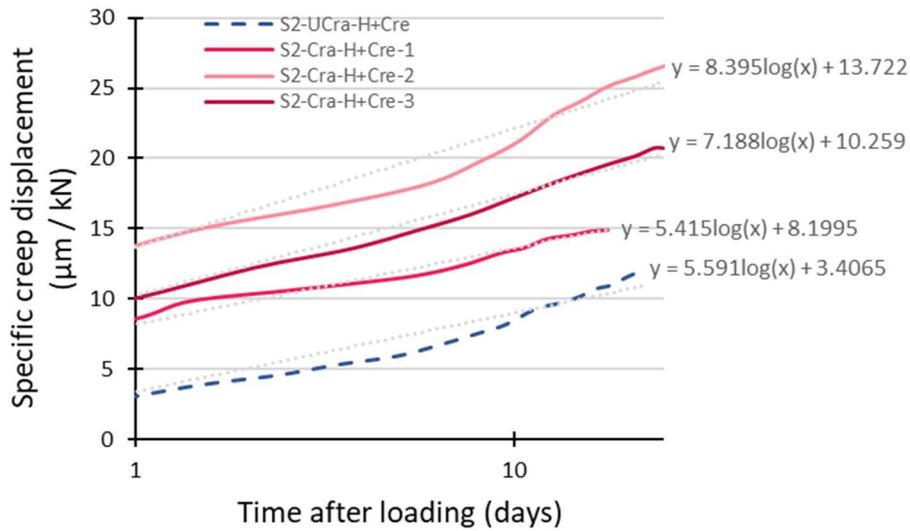
311 **Figure 8.** Specific creep displacement of the healed beams loaded with constant sustained
 312 load (specimens 1 to 3) and the reference mean uncracked beam loaded with constant
 313 sustained load: a) linear time scale, b) logarithmic time scale with regressions.

272 Figure 8 shows the specific creep displacement of specimens loaded in water during
273 healing. During the coupled creep-healing test, a rapid progression of creep displacement
274 was observed during the first day after loading during the coupled creep-healing test. In
275 fact, the value of the specific creep displacement of the precracked specimens ranged
276 from 10 to 15 $\mu\text{m} / \text{kN}$, which was about four times the value of the creep displacement
277 of the uncracked specimens subjected to the same sustained mechanical load

278 (3.5 $\mu\text{m} / \text{kN}$). This can be explained by the absence of healing products immediately
279 after cracking and a low precipitation rate for a short healing period of only one day.
280 After one day of healing, when the specimens were 3 days old, the creep displacement
281 slowed down with time for all the healing specimens, especially for specimens 1 and 2.
282 The slowing of the creep displacement in the healing specimens indicates that progressive
283 self-healing limits the progression of creep displacements. Between 1 day and 24 days of
284 healing under creep, the specific creep displacement increased by 5.4, 11.5 and
285 10.6 $\mu\text{m} / \text{kN}$ for specimens 1, 2 and 3, resp., while the specific creep displacements
286 progressed by 8.7 $\mu\text{m} / \text{kN}$ in the mean uncracked reference specimen. Therefore, the
287 specific creep displacement during this period was smaller for one specimen subjected to

288 creep and healing than for the reference, indicating a rapid progression of healing under
289 creep, while the other healing specimens exhibited a relatively rapid increase in specific
290 creep displacement. This is similar to what was reported in [32], where crack self-healing
291 in fiber-reinforced engineered concrete was measured under creep loading. This
292 observation is also consistent with the fact that a load that closes or limits the crack width
293 can help achieve better healing [39].
294 As can be seen in Fig. 8 b), the progression of creep in the healing specimens followed
295 relatively well a logarithmic behavior, although the specific creep displacement was
296 particularly slow in specimens 1 and 2 between days 1 and 10 before a relative increase
297 in speed. This could be related to the precipitation of new healing products in the crack,
298 with a stiffness close to that of the primary products of normal hydration mechanically

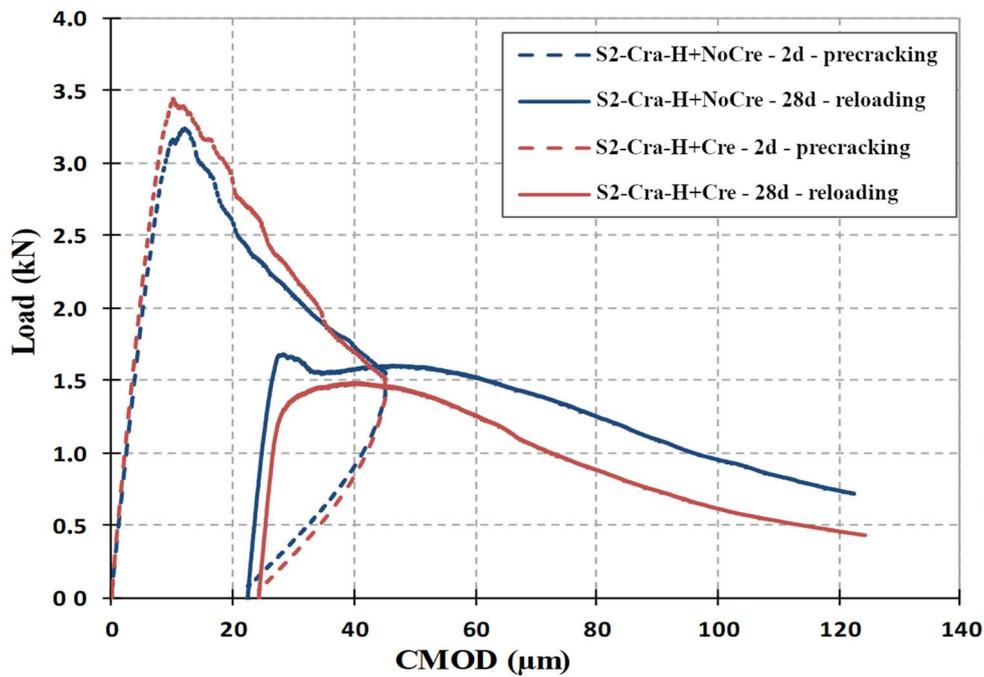
347 **Figure 9.** Comparison of load - CMOD curves for creep - healed beams and healed
 348 beams after a 26-day water immersion period.

328 Fig. 9 shows typical flexural load-CMOD curves obtained for beam specimens prepared
329 with the same mortar mix and subjected to the two different exposure regimes, i.e., with
330 or without continuous loading. In this figure, it can be seen that each curve has two parts:
331 the pre-cracking phase, consisting of loading and unloading, and the reloading phase,
332 immediately or after healing. It can be observed that there is a loss in residual flexural
333 strength of about 12% for the specimens healed under creep compared to the specimens
334 healed in water without sustained load (1.45 kN and 1.65 kN resp.). For both specimens,
335 a quasi-bilinear behavior is observed during the pre-peak phase, with the recovery of the
336 original stiffness of uncracked specimens. In addition, for the specimen healed without
337 load (S2-Cra-H+NoCre), a sharp drop is observed after the initial stiffness recovery. It is

338 likely that the crack propagates progressively in the specimens that have undergone creep,
339 compared to the other healed specimens where the cracks propagate more rapidly. This
340 sharp peak observed for the healed beams during reloading (S2-Cra-H+NoCre) can be
341 explained by the fact that the cracks are partially filled with new crystals that form during
342 healing, and therefore the initiation of the damage is different in the healed and unhealed
343 areas, as observed in [41]. These localized healing products are unable to withstand the
344 increasing load and crack initiation, which quickly triggers the brittle behavior of the
345 structure.

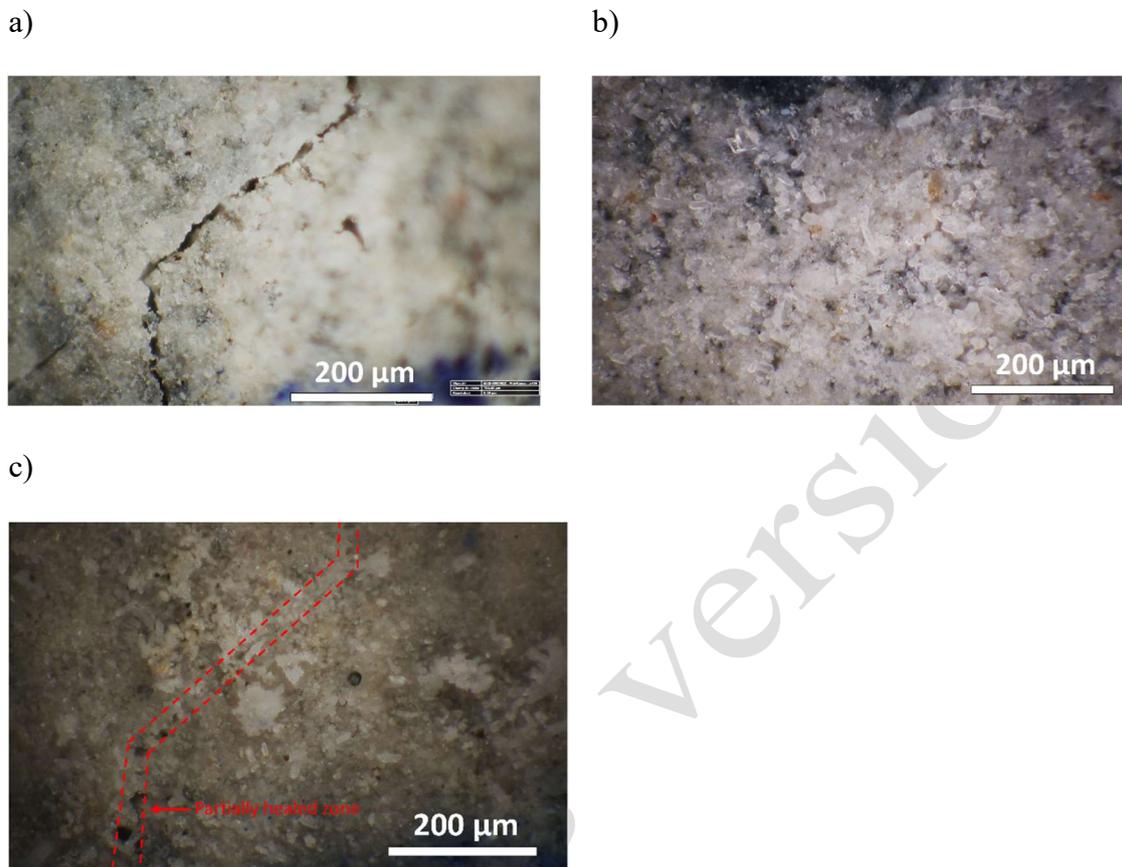
404 **Figure 11.** Microscopic images of the bottom parts of the cracks of two typical
405 specimens: a) after cracking, b) after healing without loading, and c) after simultaneous
406 healing and creep (initial crack path is given in dashed line).

385 Microscopic observations support the abovementioned mechanical findings. As
386 illustrated in Fig. 11, all the cracks showed very good overall healing due to the early-age
387 crack initiation. Fig. 11 a) is an image of the largest portion of the bottom part of an initial
388 crack prior to healing. In this image, the initial crack width was approximately 9 μm to
389 17 μm . Since the specimen is made of mortar, the crack does not show branching but its
390 orientation varies locally depending on the presence of sand particles. Similar initial crack
391 widths close to the one reported in Table 5 were observed on the other specimens.

392 After the healing period, white products were observed almost all along the cracks
393 initially present on the S2-Cra-H+NoCre specimens, as illustrated in Fig. 11 b). The initial
394 crack path shown in the image is barely visible. This finding agrees with the previously
395 published studies on the very good autogenous healing capacity of thin early-age cracks
396 [43]. These white products visible at the surface are mostly calcium carbonate
397 polymorphs, and locally cloudy-like CSH was observed [25].

398 Conversely, it has been observed that healing products did not cover the entire crack
399 surface of the specimen subjected to sustained loading (S2-Cra-H+Cre). As illustrated in
400 Fig. 11 c), some zones of the initial crack were not filled with healing products, such as
401 the lower left part of the crack in the given image. This observation is consistent with the

402 lower mechanical recovery observed for mortar specimens, which can be attributed to the
403 lower healing capacity of mortar specimens subjected to creep, as suggested by [44].
